# 2015 Cleveland Metroparks Hydrilla Report

Cleveland Metroparks Technical Report 2015/NR-01

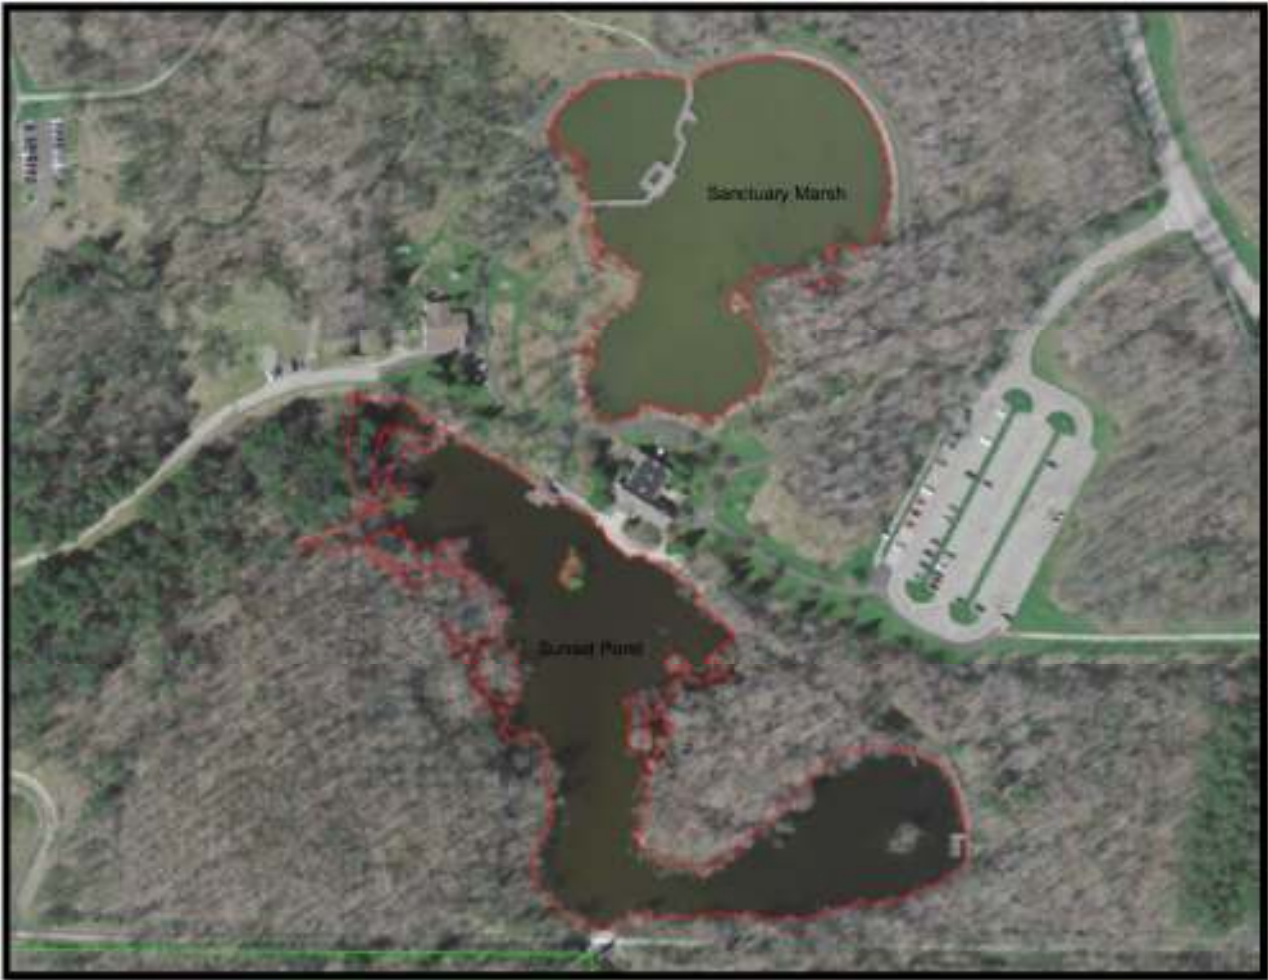
Map 1. Sunset Pond and Sanctuary Marsh in North Chagrin Reservation

Sunset Pond is a 5.2 acre man-made pond located in North Chagrin Reservation. The pond is a popular location for waterfowl, both local and migratory, and has been utilized as a brood-stock source for game fish by Cleveland Metroparks. A water-control structure is located at its outflow to Sanctuary Marsh. Hydrilla was found in Sunset Pond in 2012, consisting of several strands along the deck behind the North Chagrin Nature Center. A 2013 survey failed to locate Hydrilla, but was hampered by excessive algae growth throughout the pond. A 2014 survey located Hydrilla in the same area and density as the 2012 occurrence.

Sanctuary Marsh is a 3.7 acre created wetland located in North Chagrin Reservation. It is a popular location for waterfowl, both local and migratory, as well as other wildlife, and is crossed by a boardwalk. The marsh is used extensively by North Chagrin Nature Center staff for educational programs. It has a water-control structure at its outflow to Buttermilk Creek, a tributary of the Chagrin River. Cleveland Metroparks has regularly conducted boat electrofishing to remove non-native goldfish from the marsh. Hydrilla was found in Sanctuary Marsh in 2012, consisting of substantial mats in shallow areas around the boardwalk and pond dipping dock.

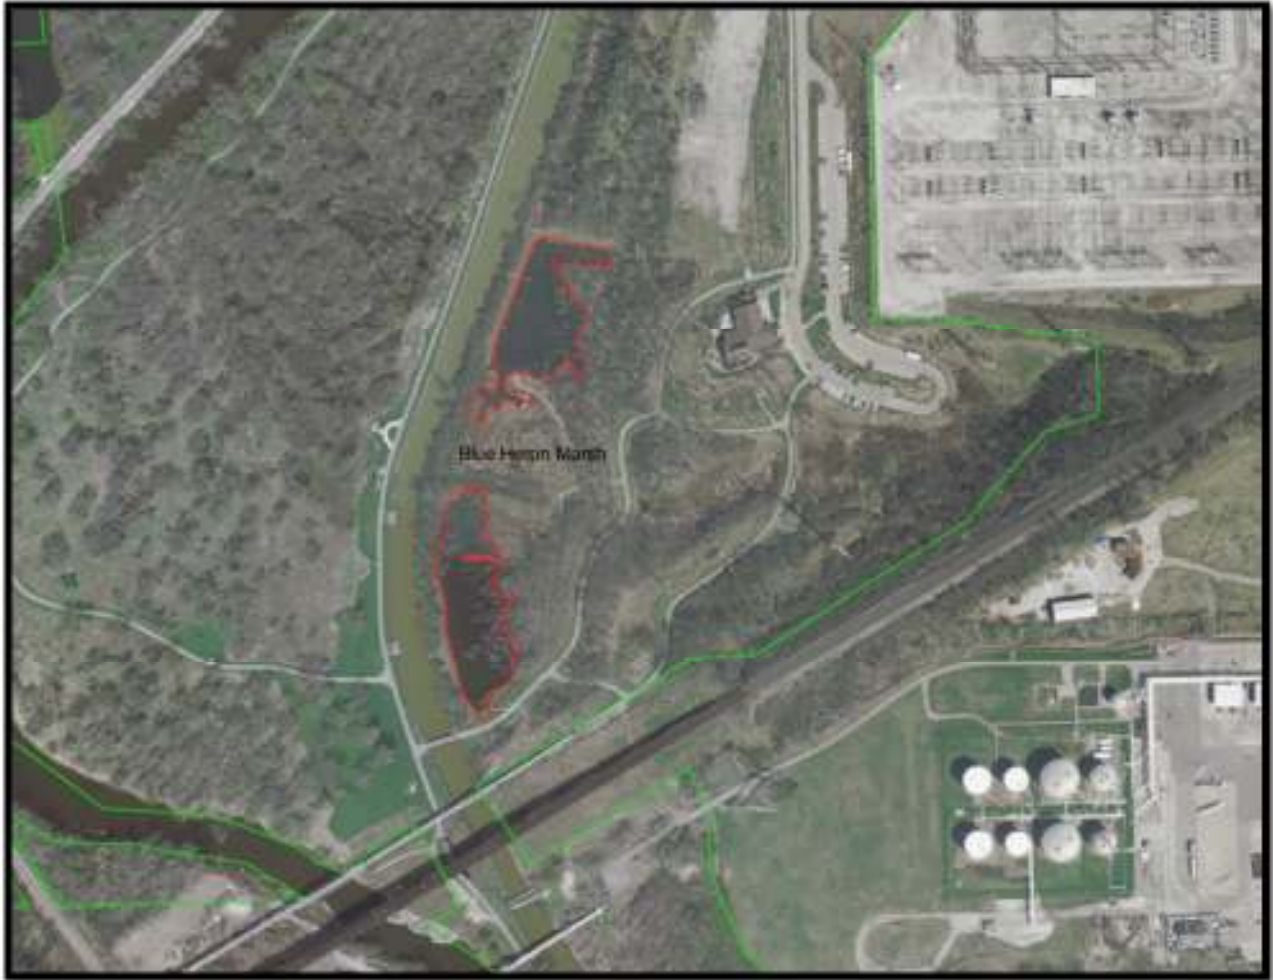
Map 2. Blue Heron Marsh in Ohio & Erie Canal Reservation

Blue Heron Marsh consists of two hydrologically connected wetland cells that discharge into the Ohio & Erie Canal. Their water levels can be modified using a water-control structure at one of the outflows into the Canal. Portions of the marsh have a boardwalk and pond dipping dock, which is utilized by CanalWay Visitor Center staff for educational programs. Additionally, a long-term Blanding's turtle study, including the release of head-started turtles and the tracking and trapping of turtles in the marsh has taken place in the wetlands for several years. A single strand of Hydrilla was found in the marsh in 2011 and subsequent surveys found multiple small, sparse patches of Hydrilla in the southern wetland cell.
