# 2017 Cleveland Metroparks Hydrilla Report

Cleveland Metroparks Technical Report 2017/NR-01

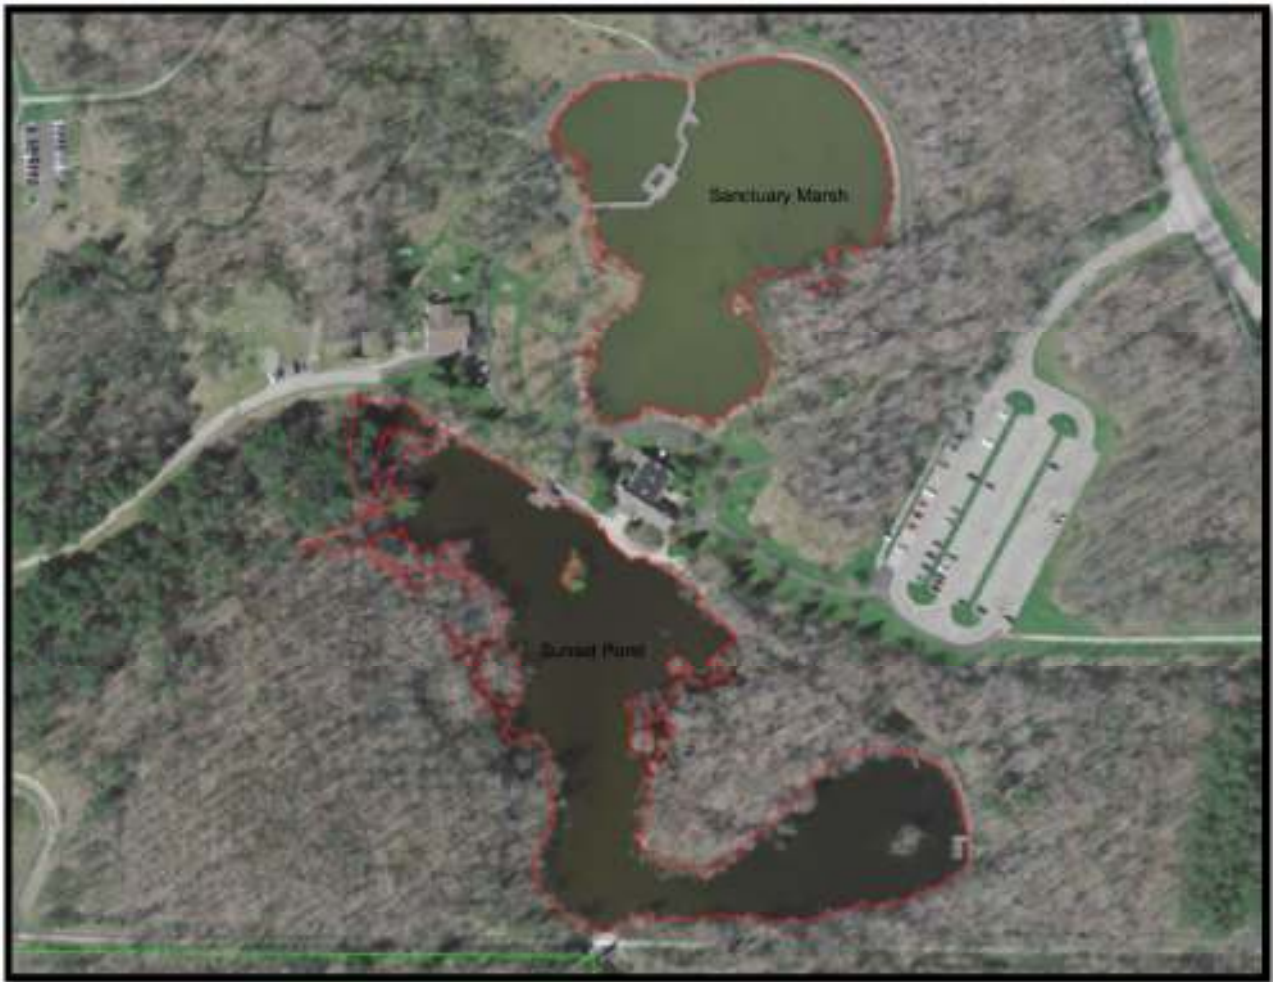
Map 1. Sunset Pond and Sanctuary Marsh in North Chagrin Reservation

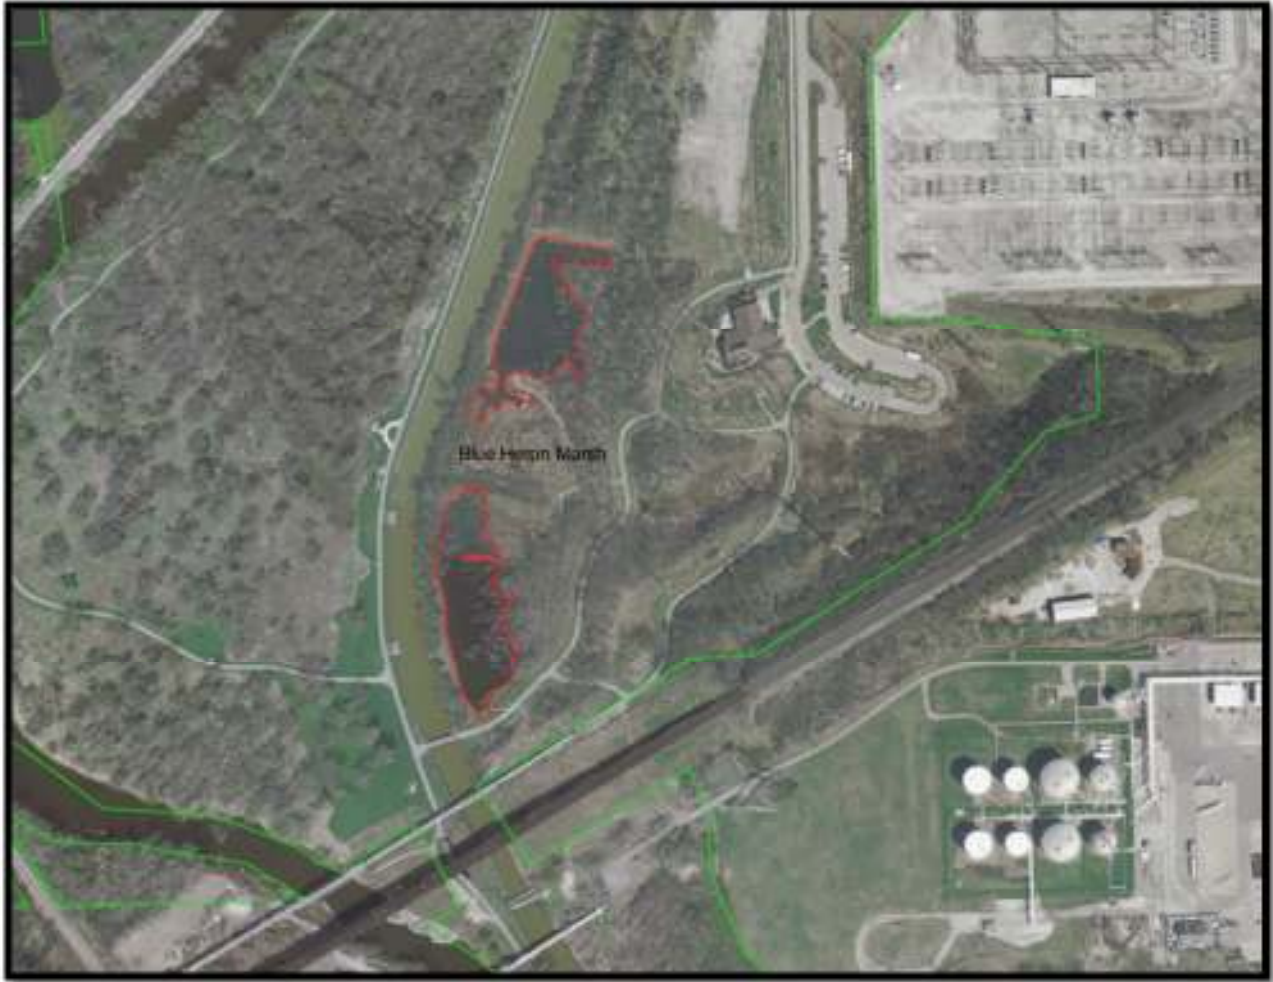
Map 2. Blue Heron Marsh in Ohio & Erie Canal Reservation

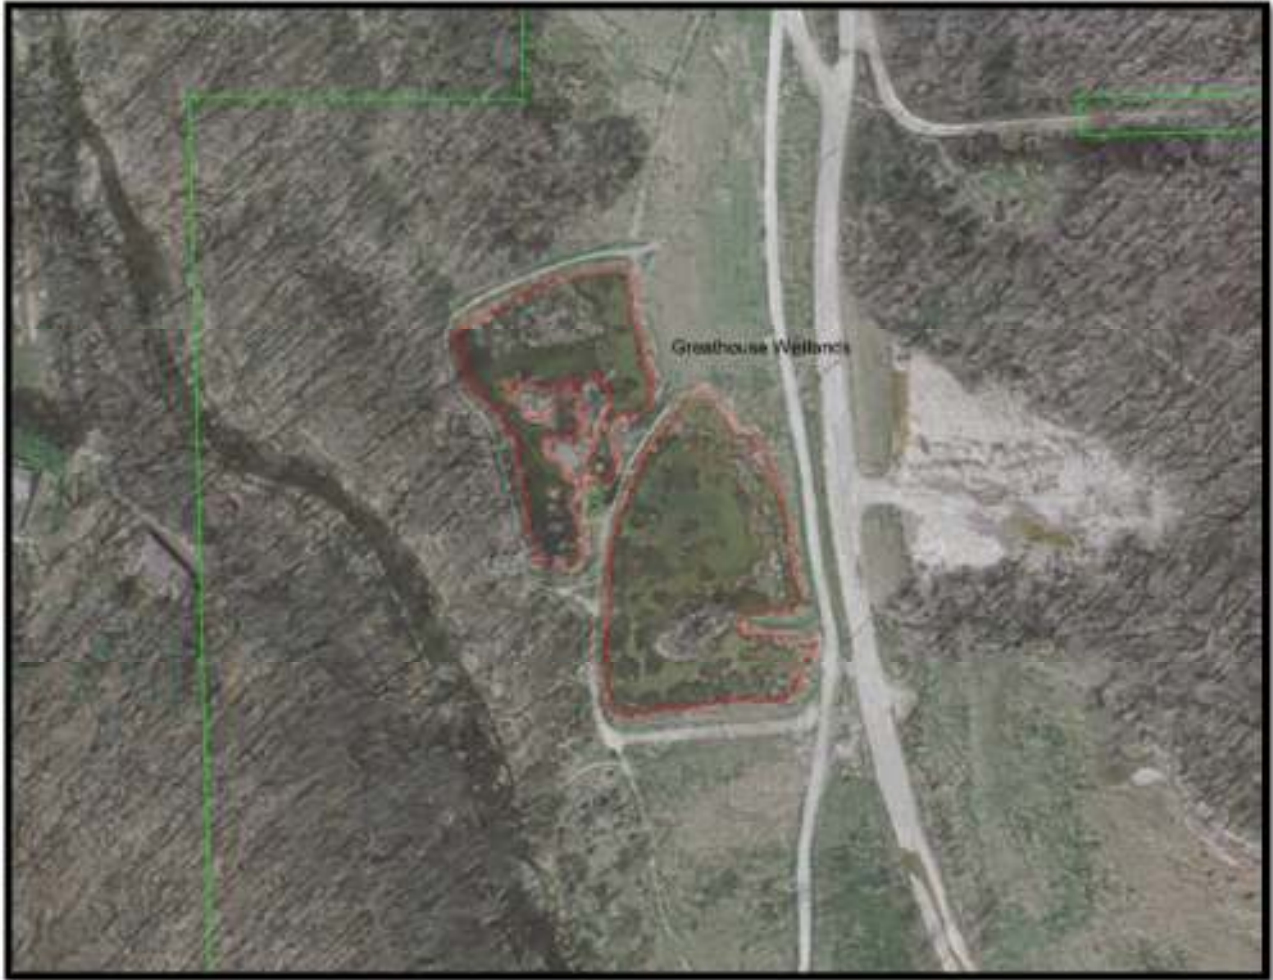
**Map 3. Greathouse Wetlands in West Creek Reservation**

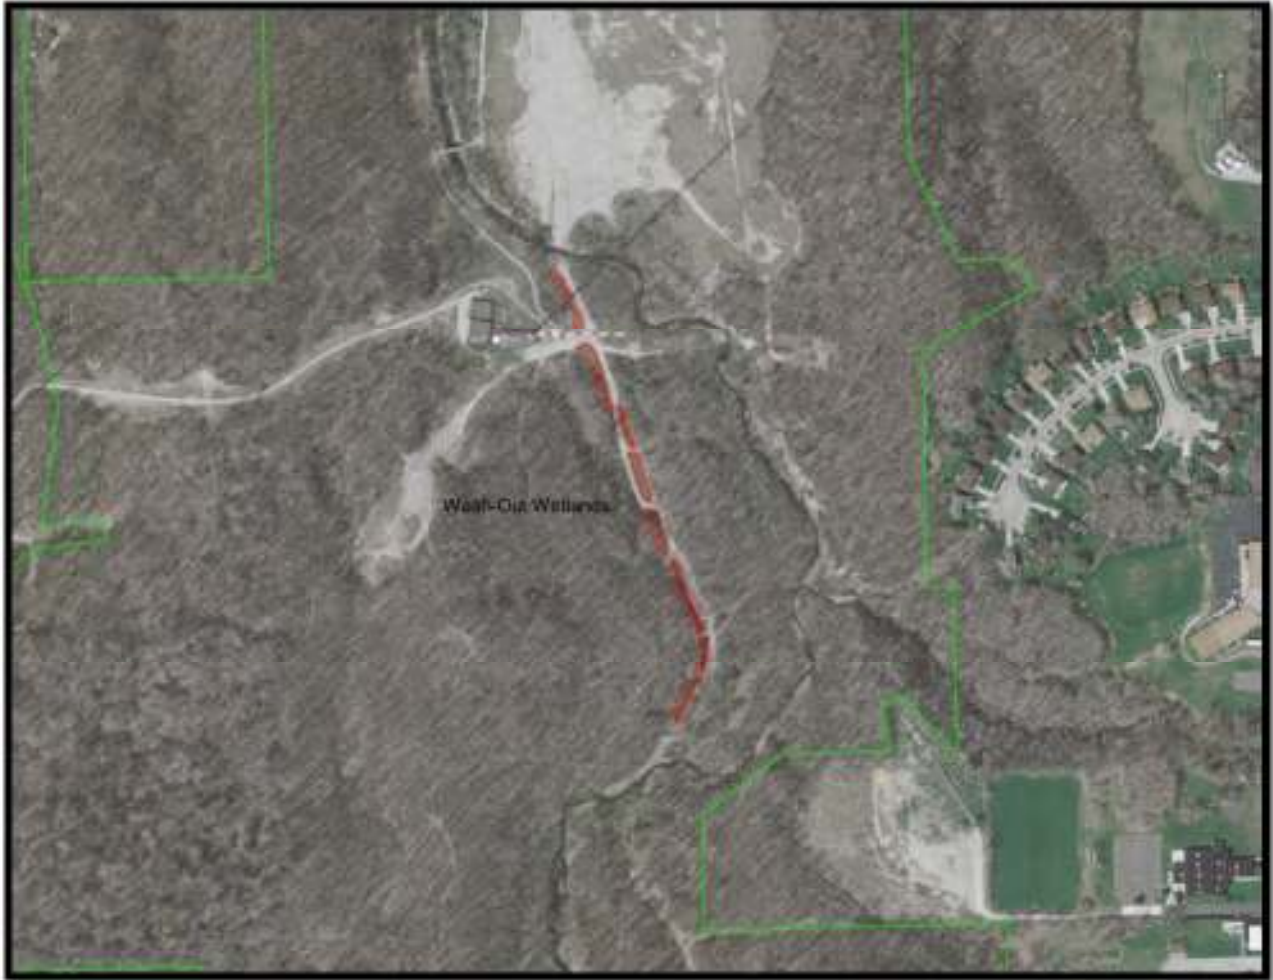
Map 4. Wash-Out Wetlands in West Creek Reservation

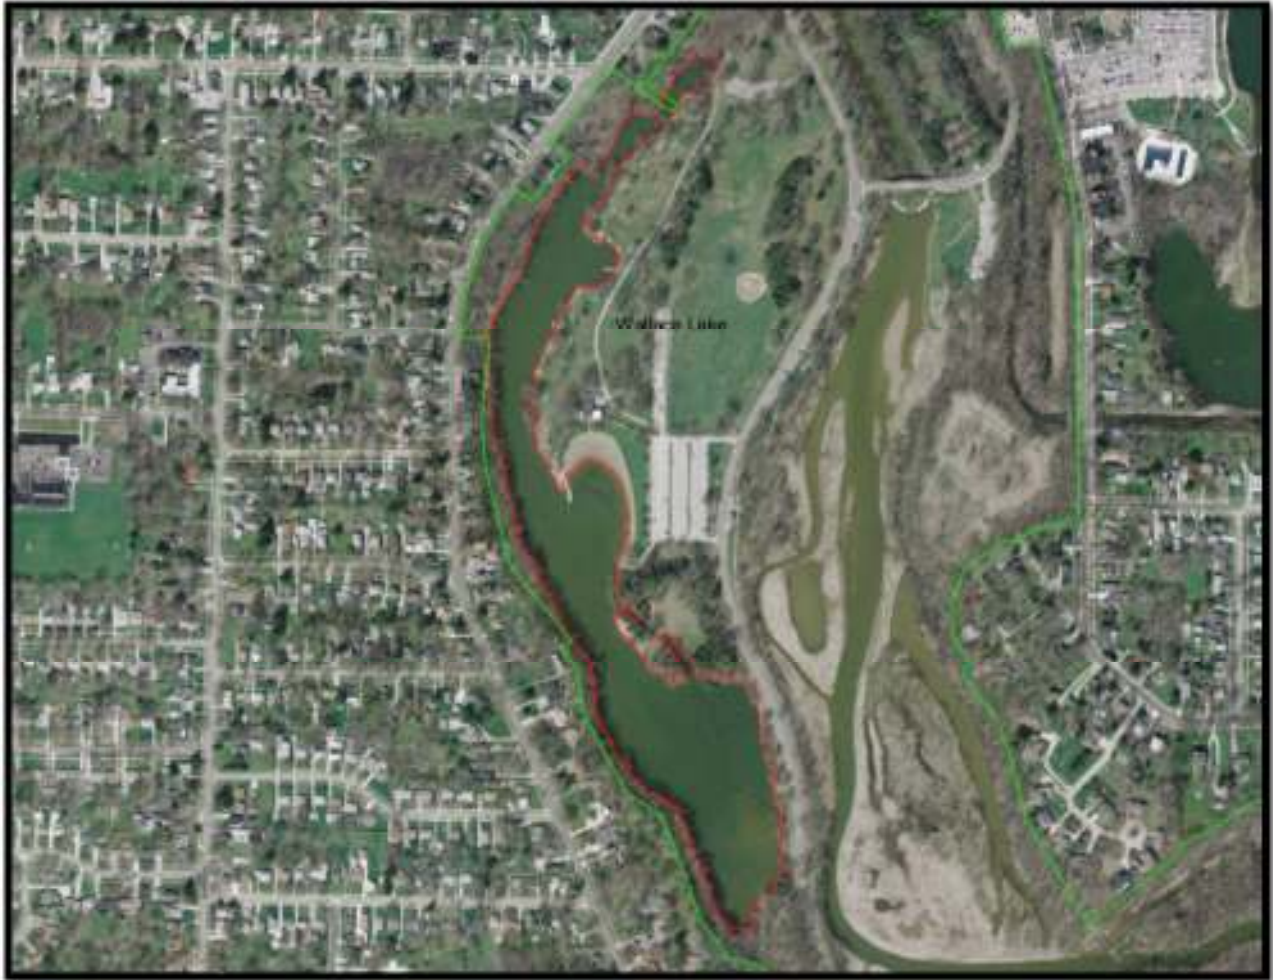
Map 5. Wallace Lake in Mill Stream Run Reservation
